~~CONFIDENTIAL~~  
**BUREAU OF SHIPS GROUP**  
**TECHNICAL INSPECTION REPORT**  
~~CONFIDENTIAL~~

**6 OPERATION CROSSROADS.**  
**U.S.S. BRULE (APA 66).**

**TEST ABLE [U].**

BUREAU OF SHIPS GROUP  
TECHNICAL INSPECTION REPORT

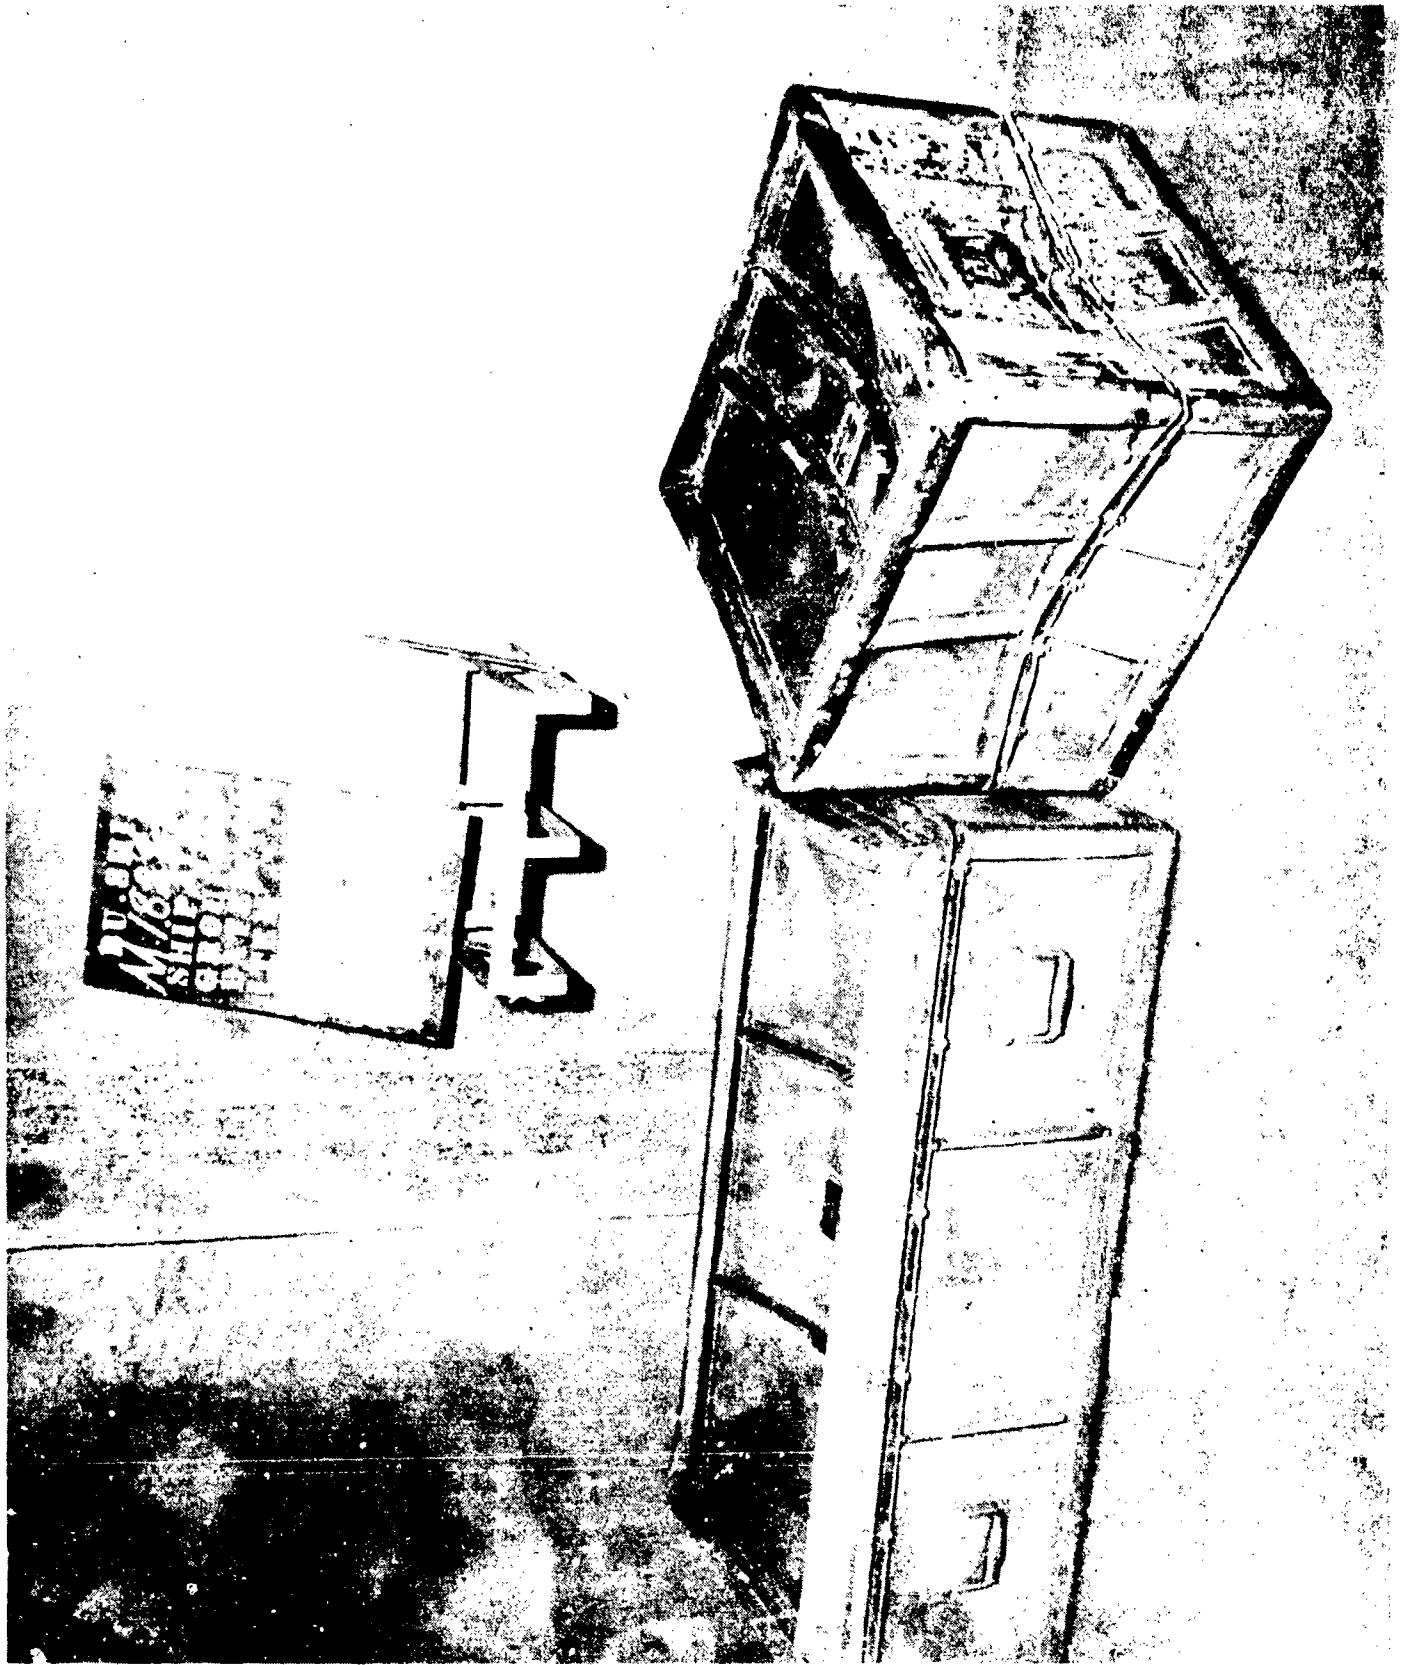
AA-CR-82-1828-7. Spare parts boxes for P.A.B. speaker. Dished in sides and top show effect of pressure on bridge level.

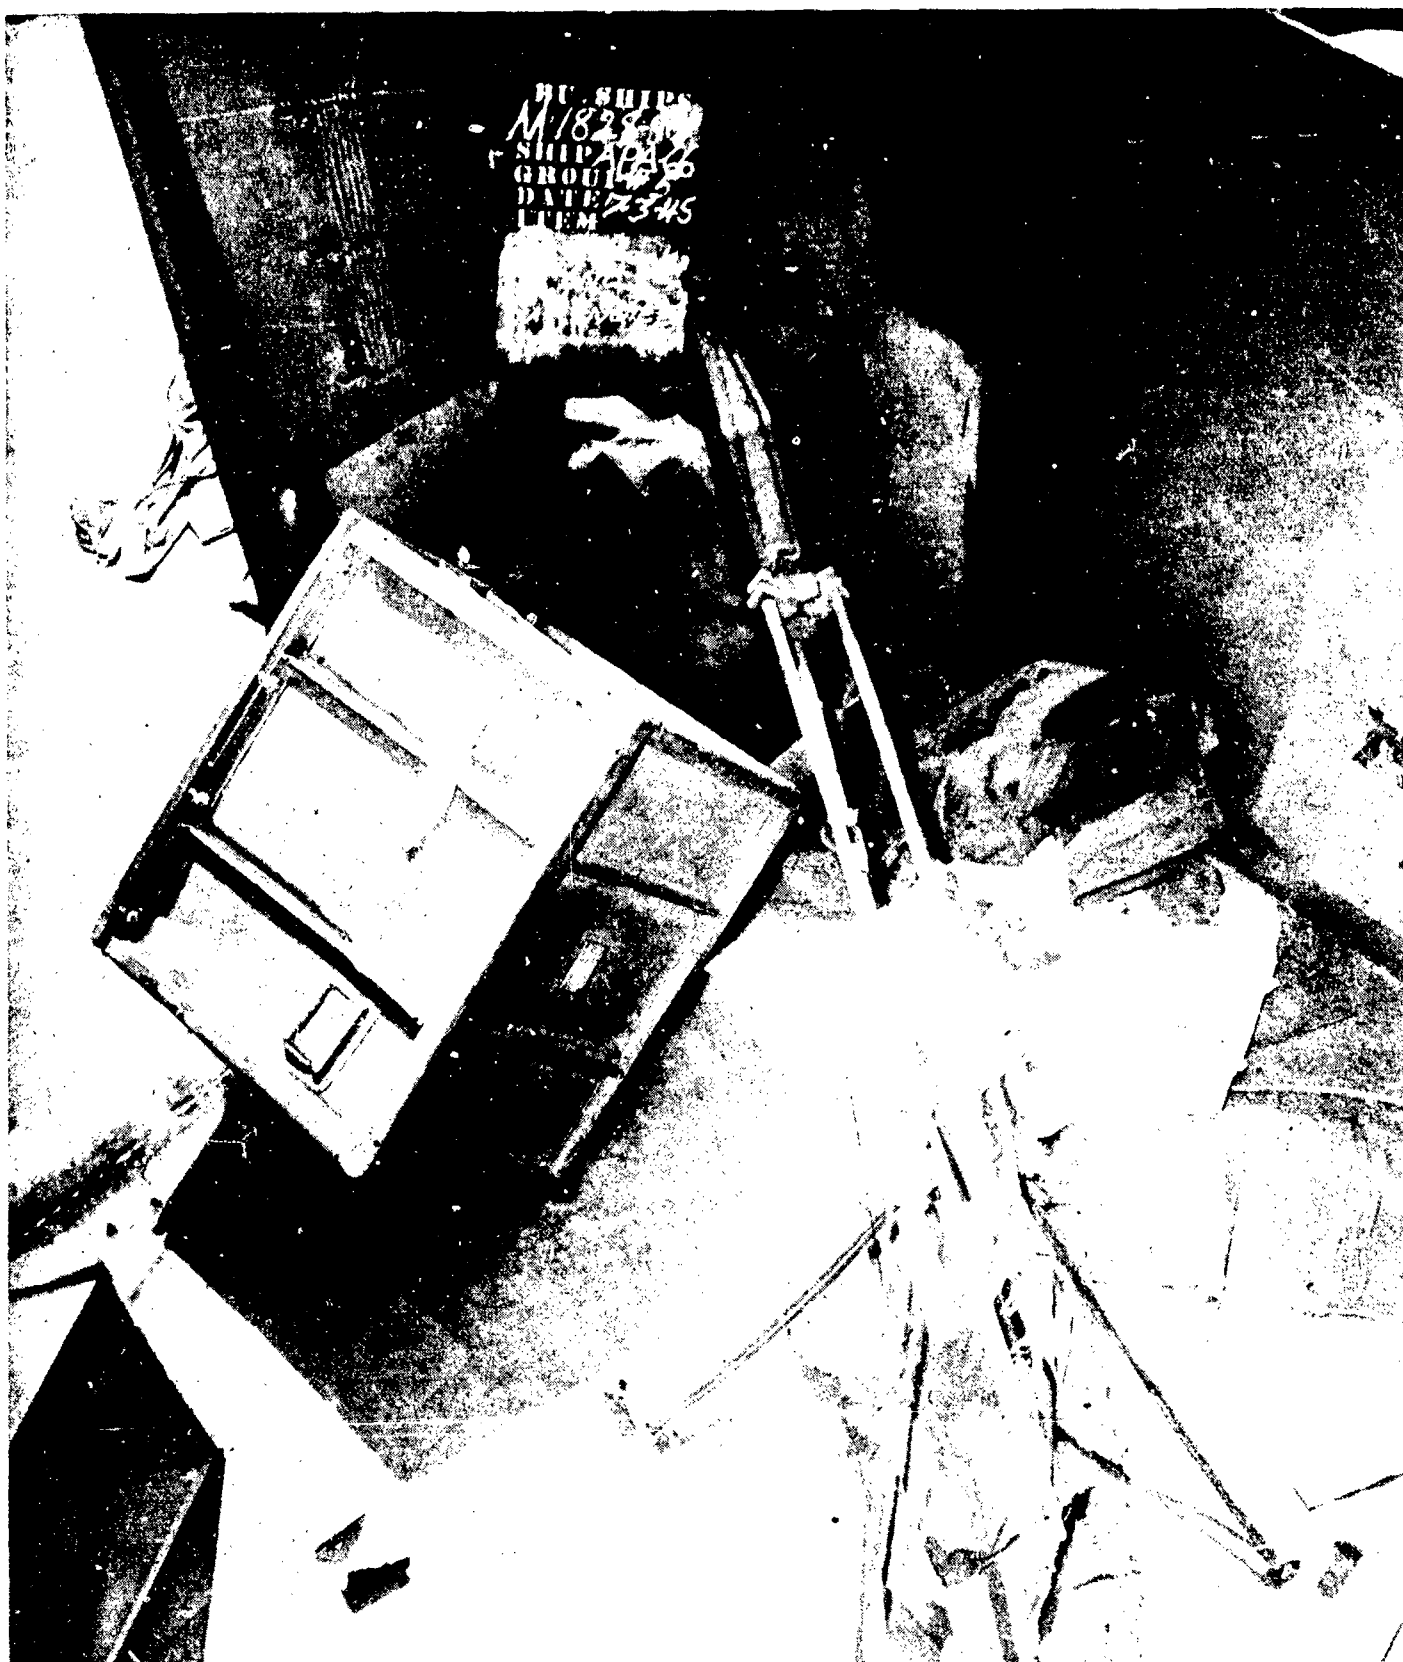
AA-CR-82-1828-10. Support for P.A.B. speaker Photo shows support damaged due to blast.

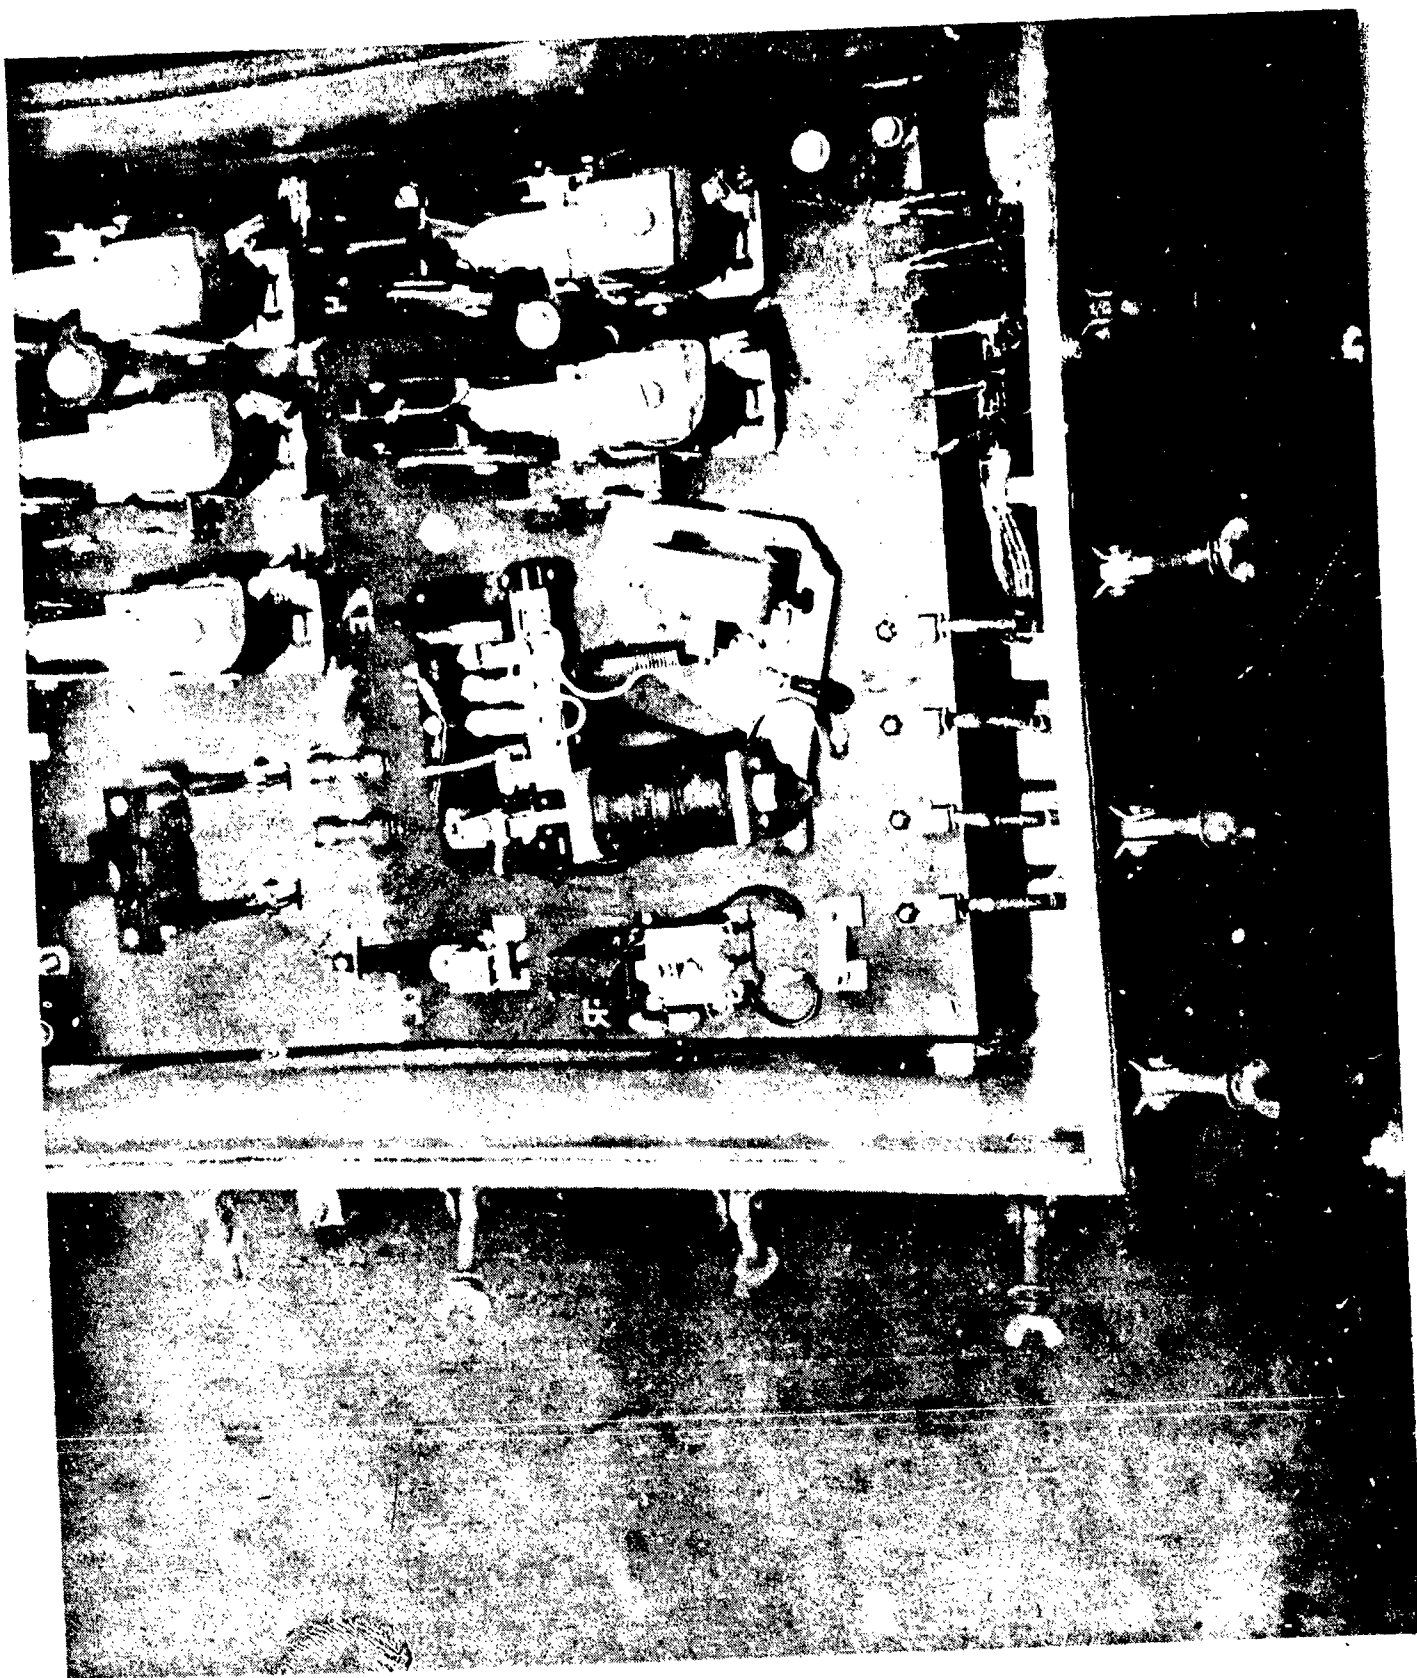
1. Dishing and whipping of starboard outboard bulkhead on main deck cracked insulating panels of boat davit controllers.

AA-CR-175-2156-12. Controller for forward starboard boat davits. Photo shows cracked main panel of ebony asbestos and broken and sub panel of molded pheuolic. Damage was due to whipping of bulk-head due to blast.

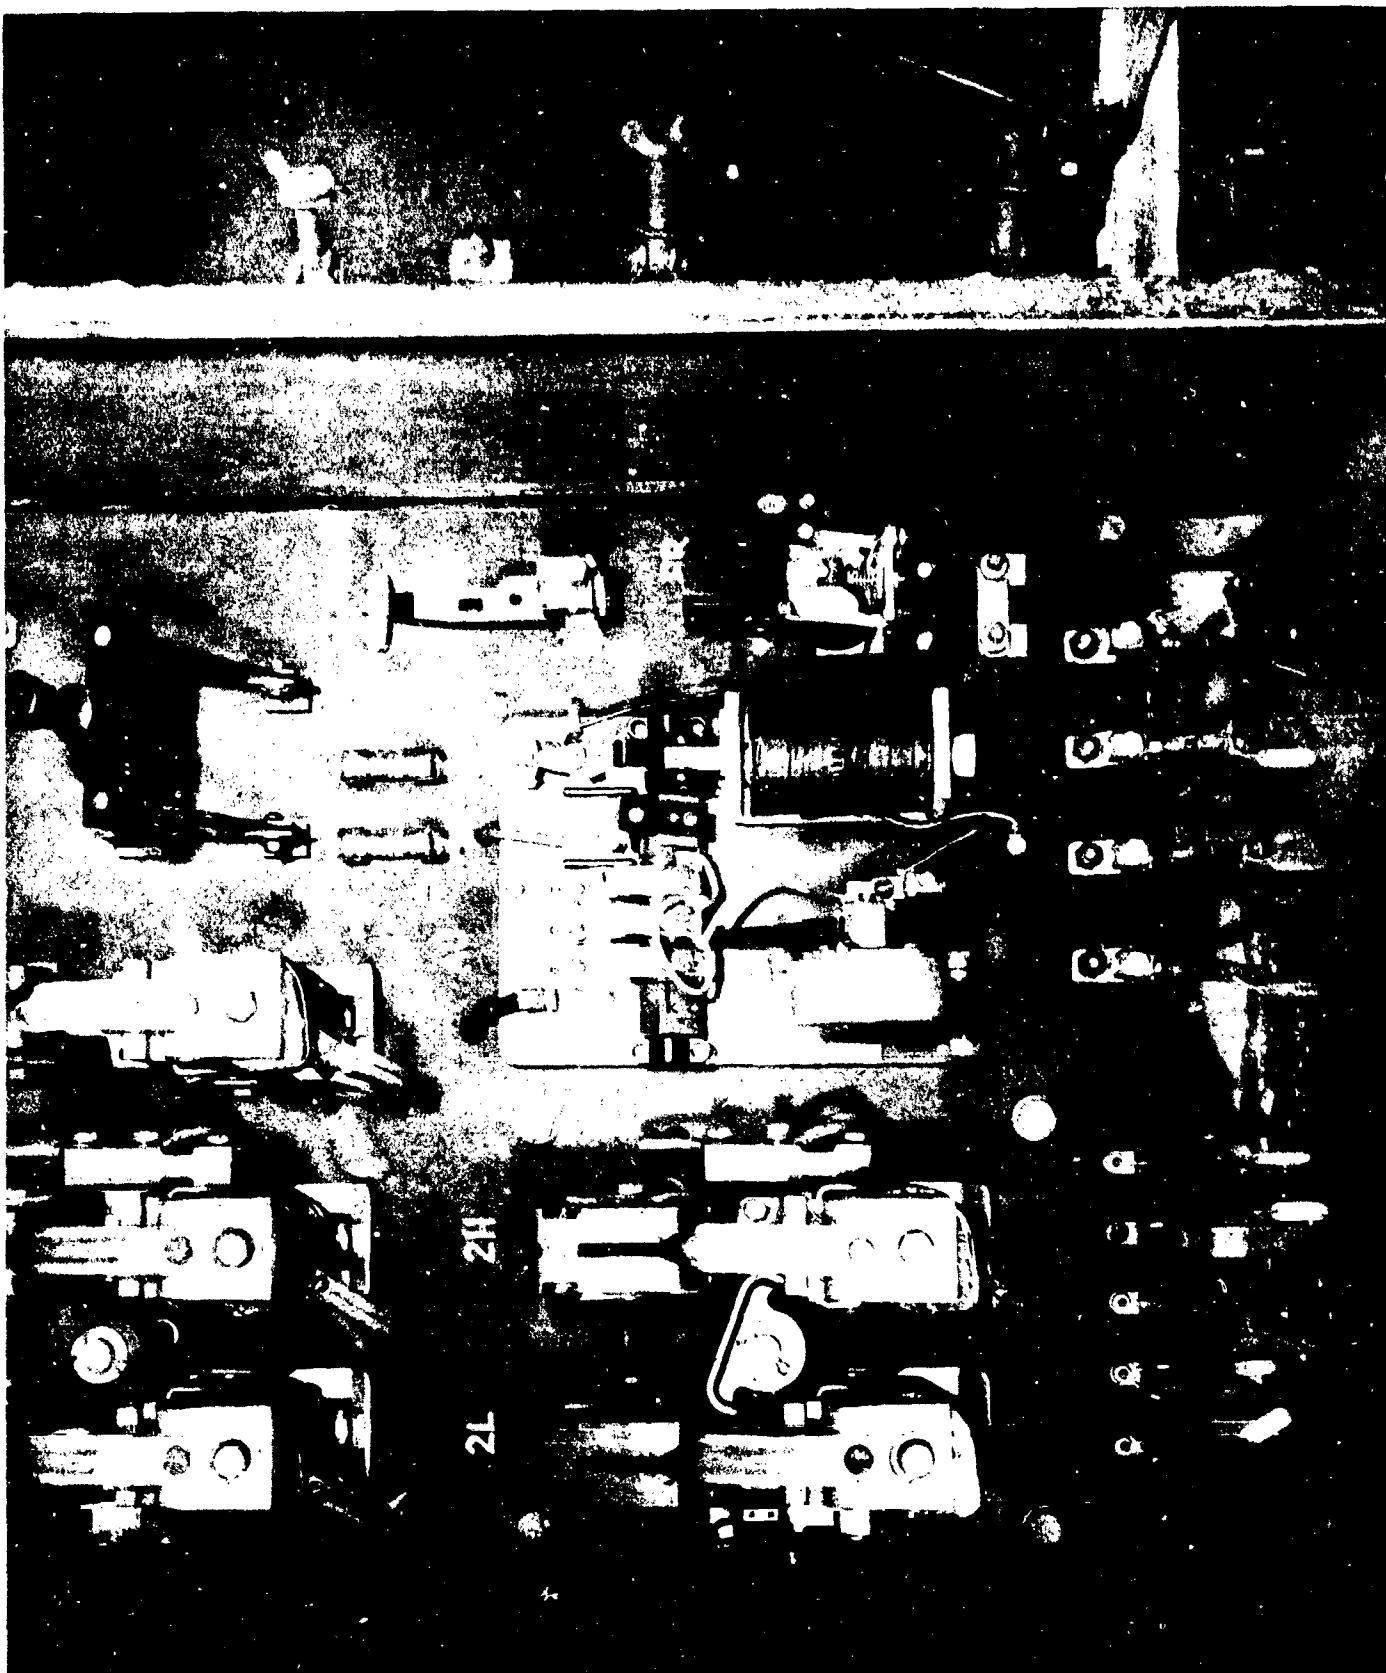
AA-CR-175-2156-11. Controller for after starboard boat davit. Photo shows cracked main panel of ebony asbestos and sub panel of molded pheuolic. Damage was due to whipping of bulkhead due to blast.
